Application of *Bird Free* to La Chiesa della Spina,  
Pisa, 1 December 2015.

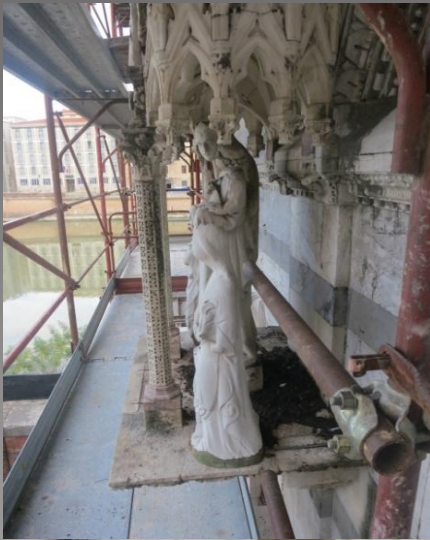
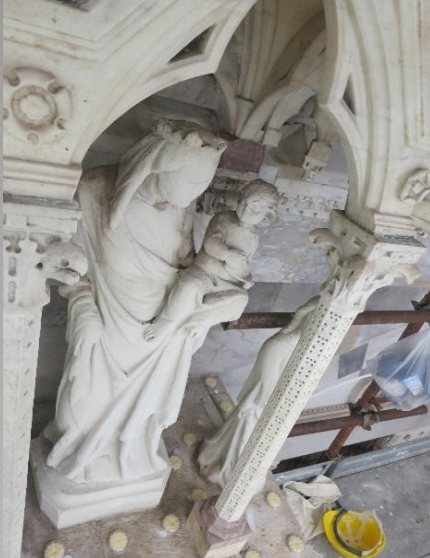
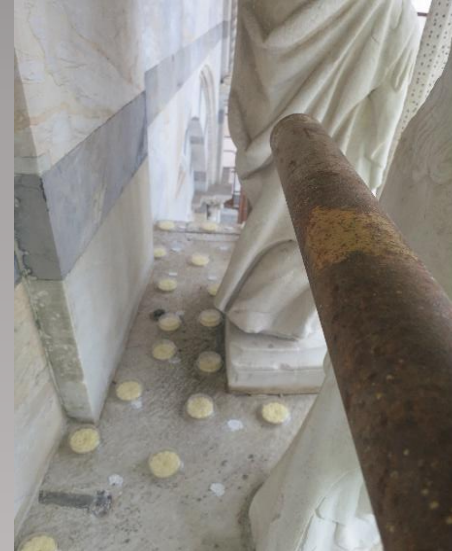
An inspection of the church was carried out in December 2014 prior to the start of renovation works. At the first floor of the west elevation, pigeons had been nesting behind the statue of Madonna and child. The base of the statue was treated with *Bird Free*, in December 2015, after renovation was completed, to prevent nesting.

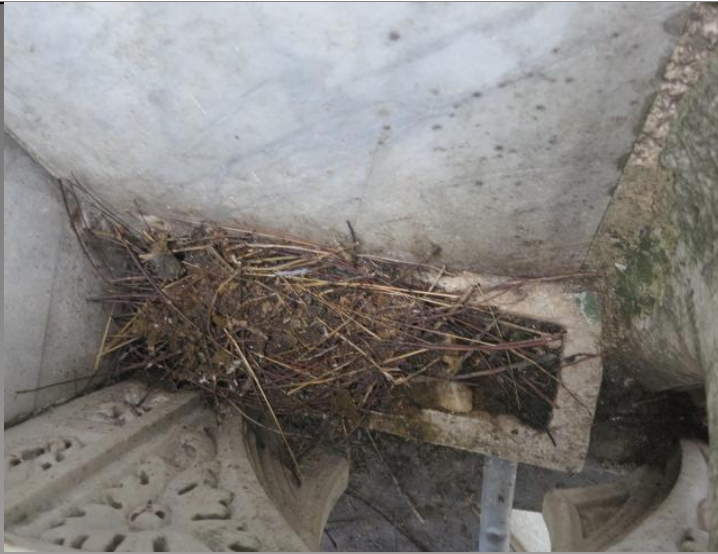
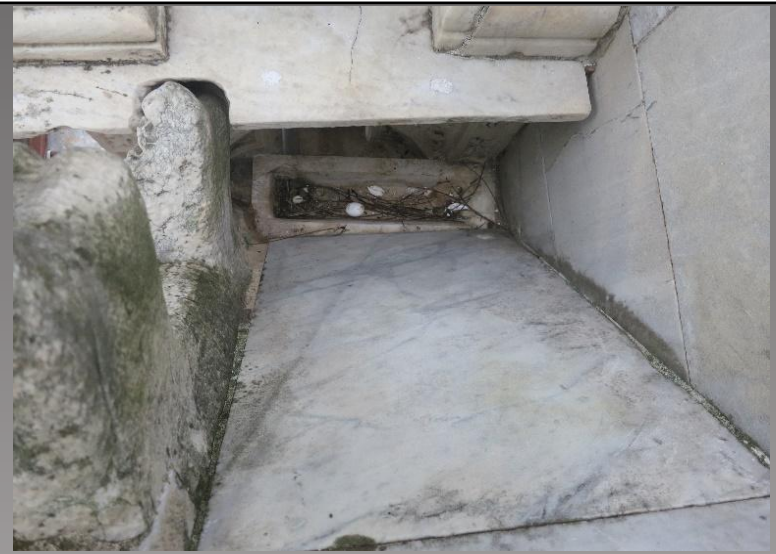
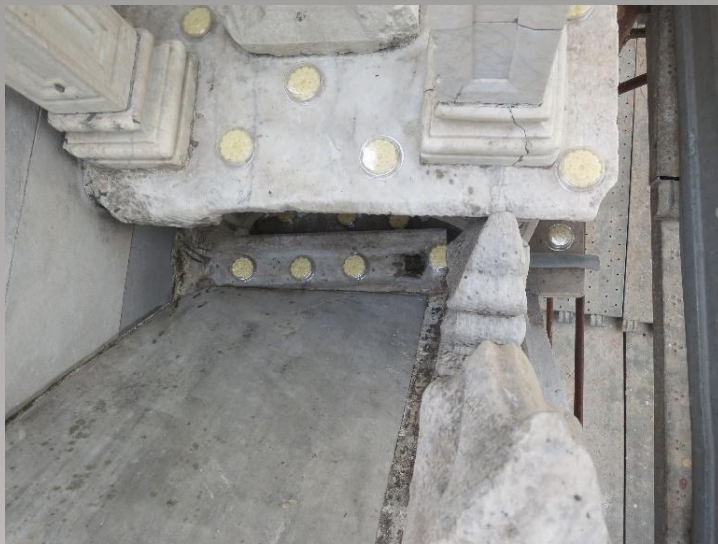
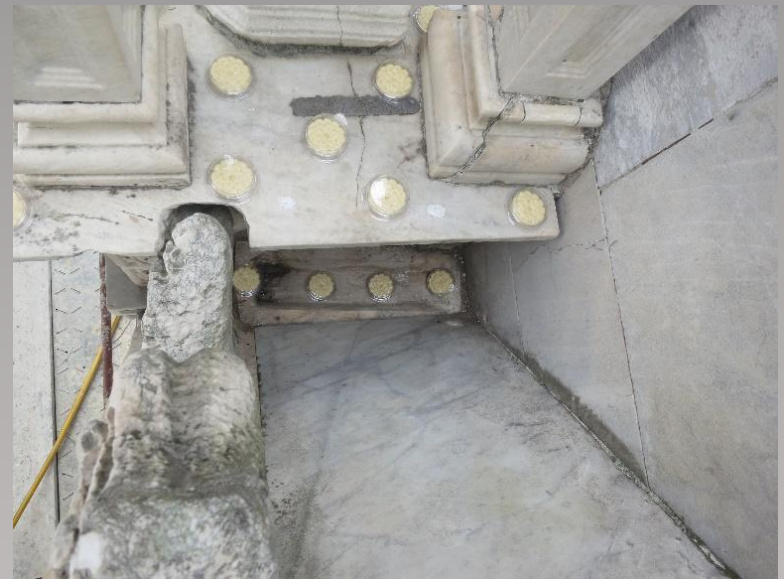
In December 2014, nests were observed in the two drains at the second floor of the west elevation. Although these nests were removed, pigeons had again nested in one of the drains. The drains were treated in December 2015 with *Bird Free*, as shown above.

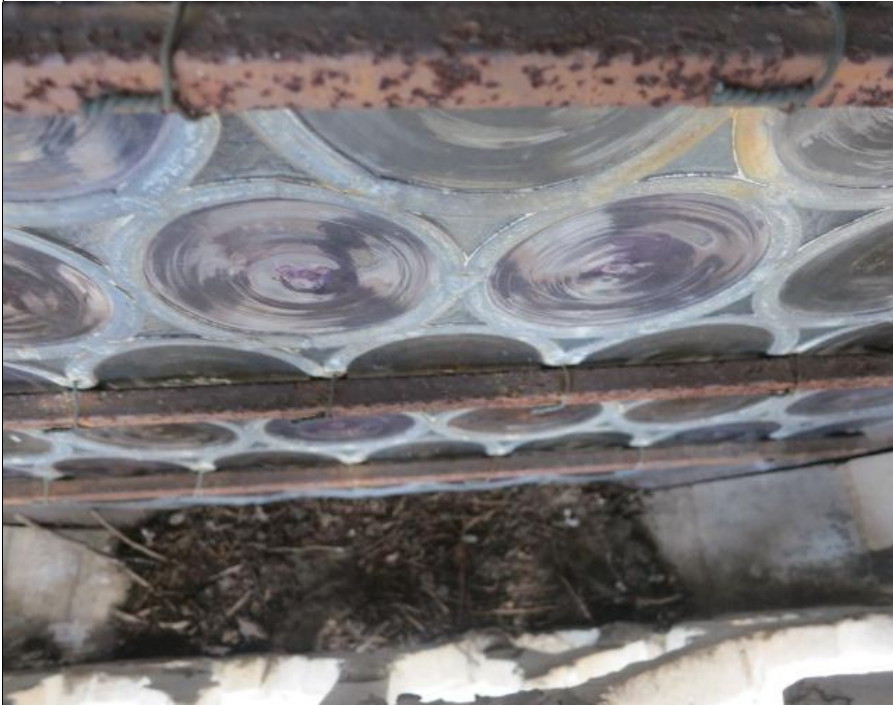
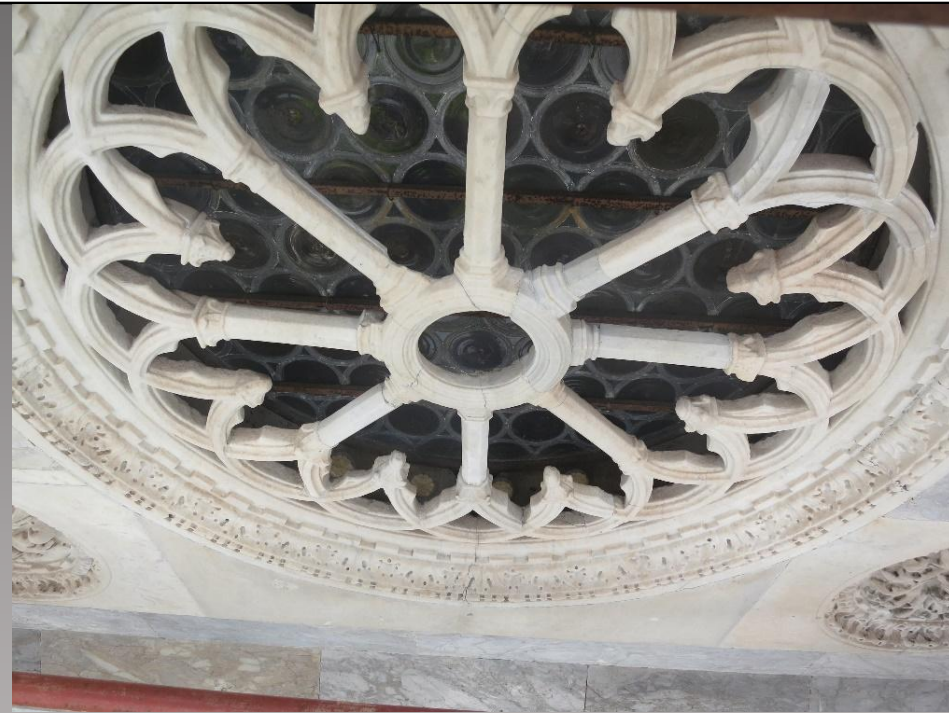
In December 2014, nests were observed at the bottom of the two circular windows at the second floor of the west elevation. These were treated with *Bird Free* in December 2015 to prevent further nesting.

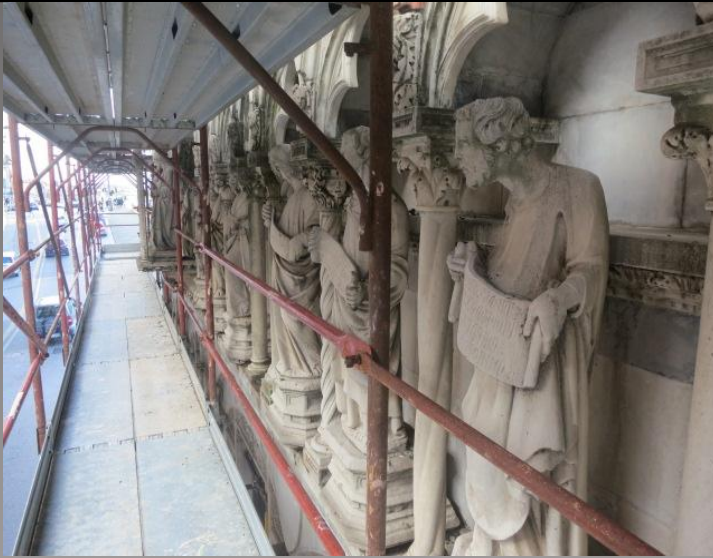
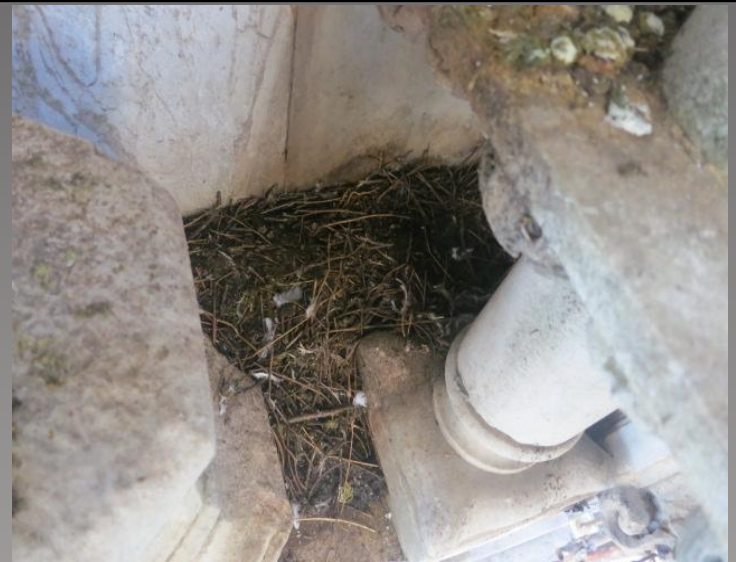
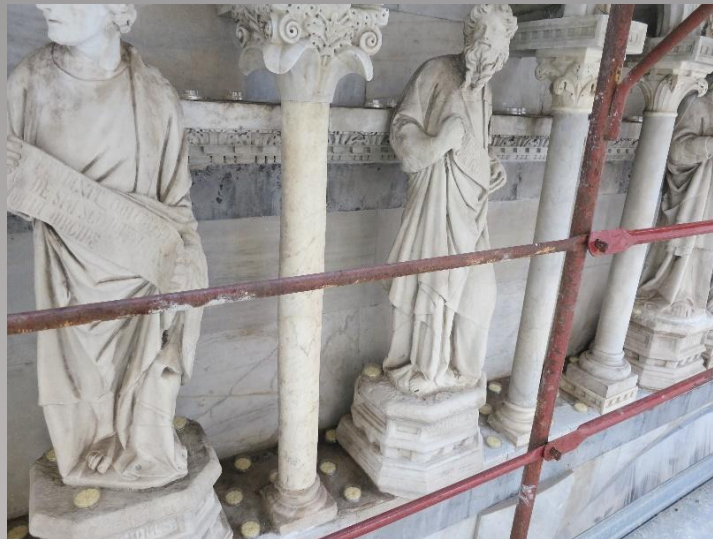
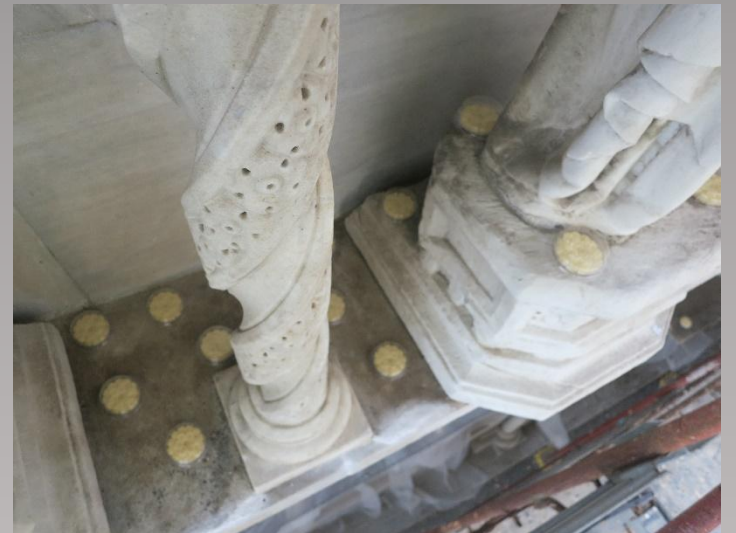
In December 2014, eight nests were observed behind the bases of the 13 statues at the second floor of the south elevation. In December 2015, the bases of the statues were treated with *Bird Free* as shown above.

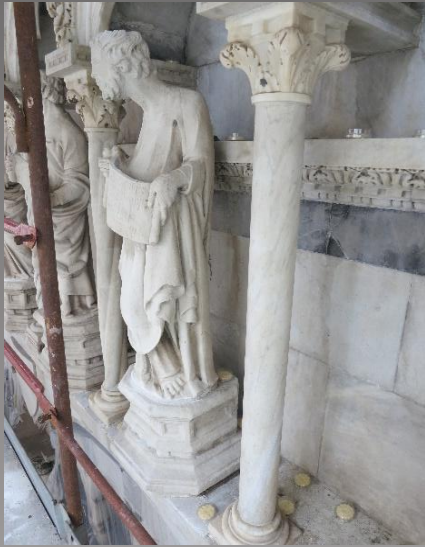
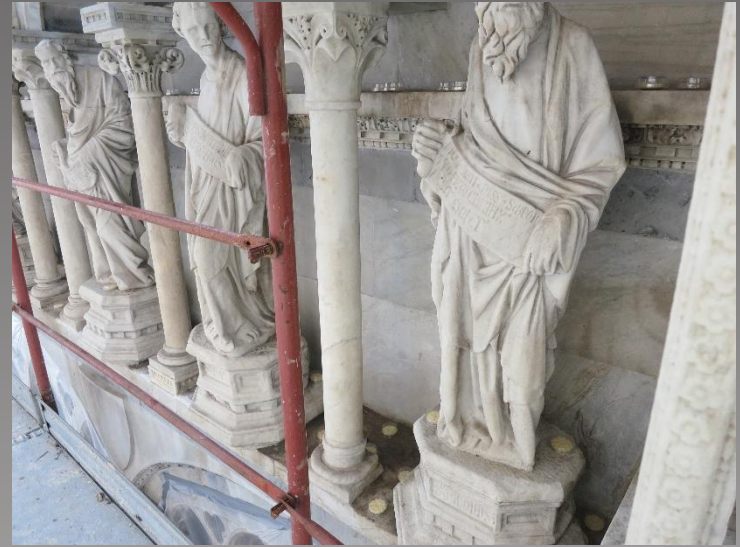
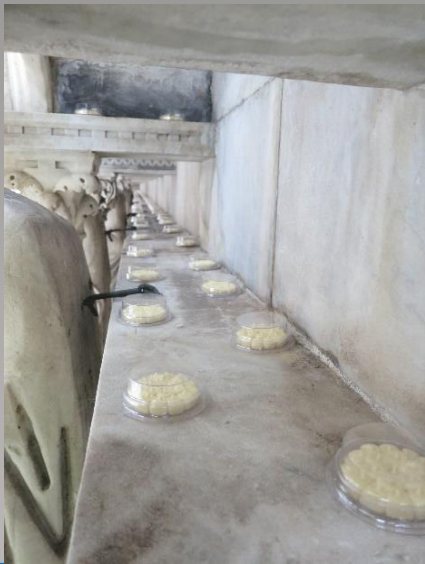
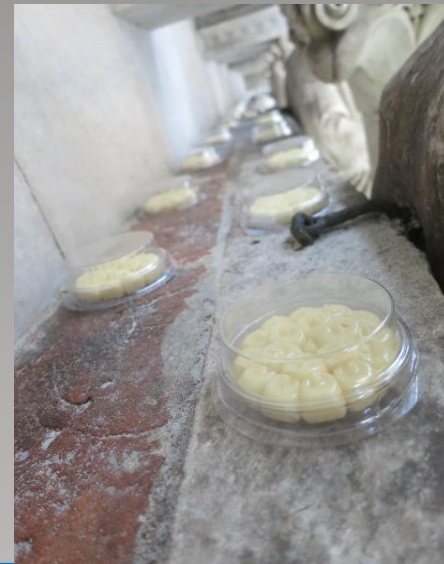
The ledge that runs behind the statues at shoulder height was treated with dishes of *Bird Free*, as shown above, to prevent roosting. (All covers were subsequently removed from the dishes.)

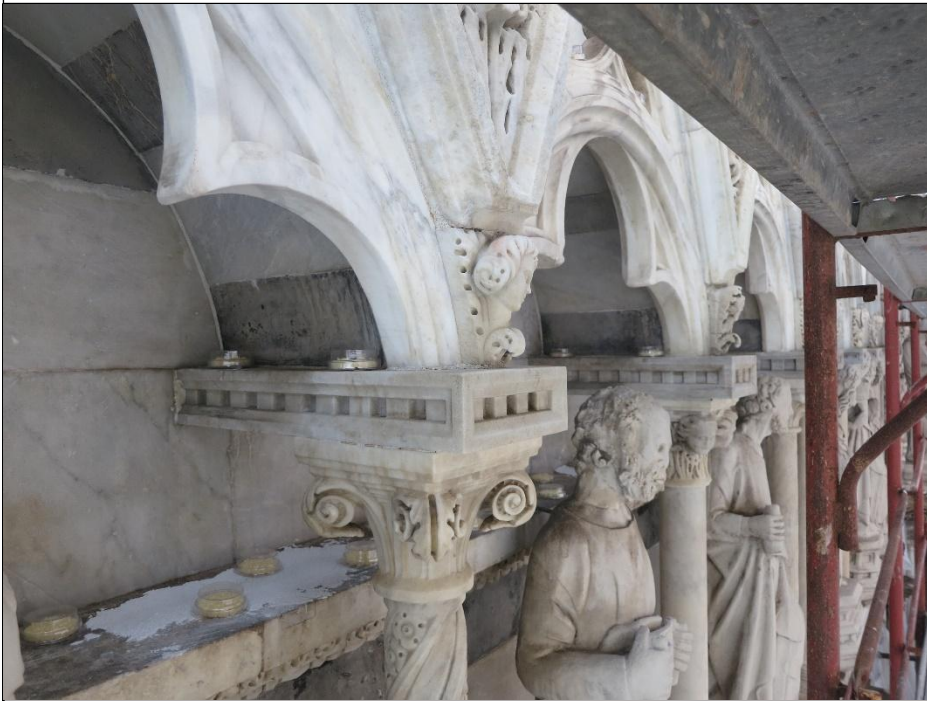
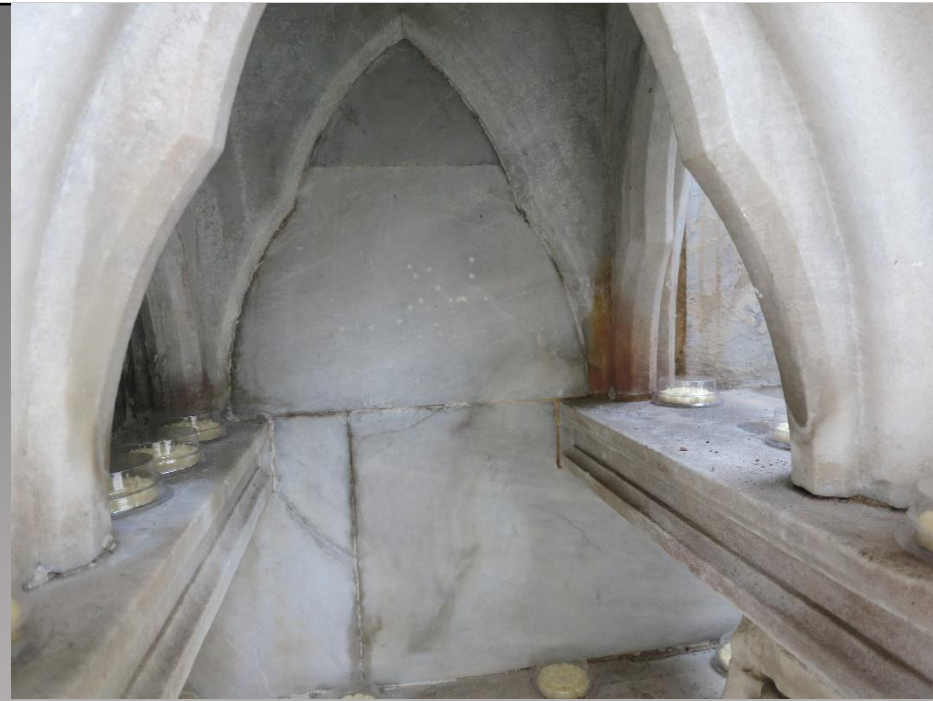
There was evidence of roosting on the small enclosed ledges above the statues. These ledges were treated with dishes of *Bird Free* as shown above.

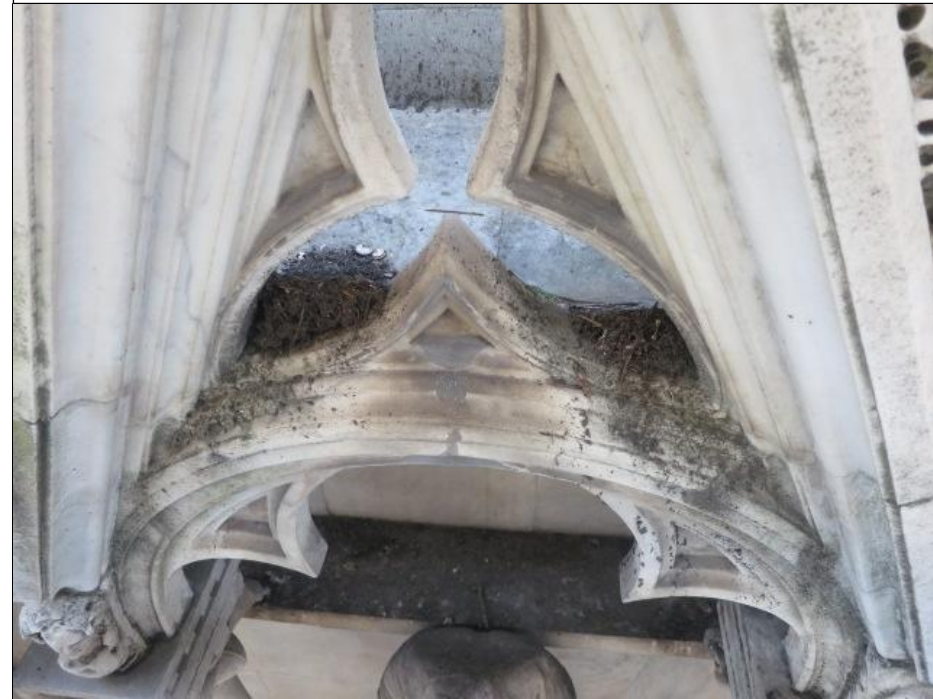
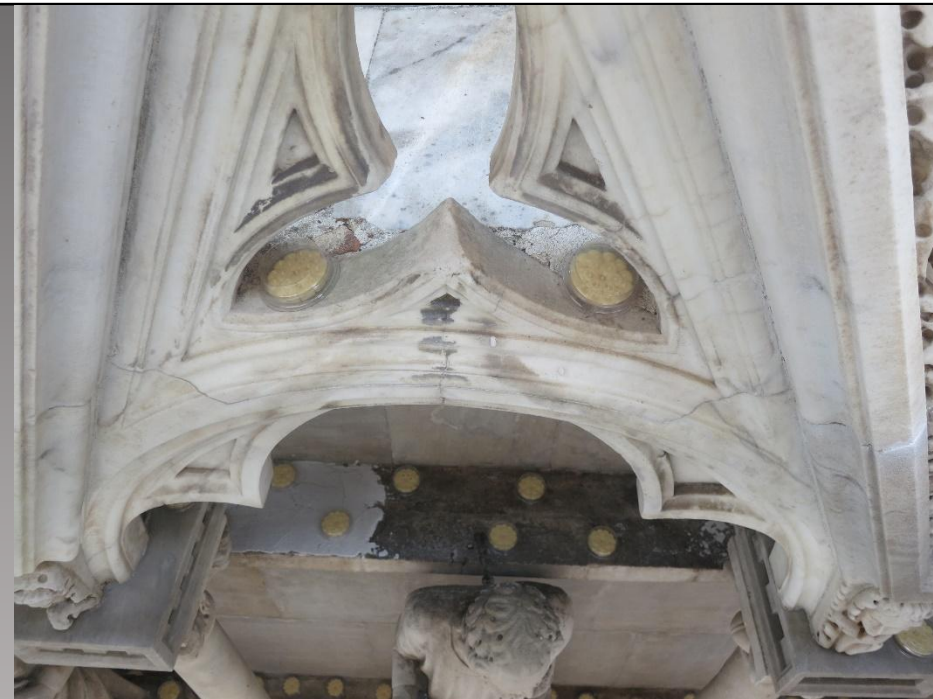
At the third floor of the south elevation, all corners of the openings above the statues were treated with dishes of *Bird Free* to prevent further roosting.

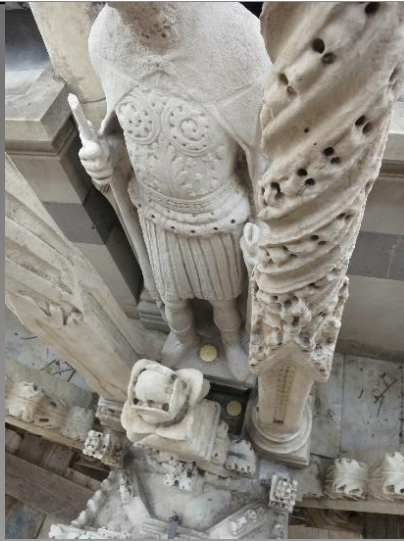
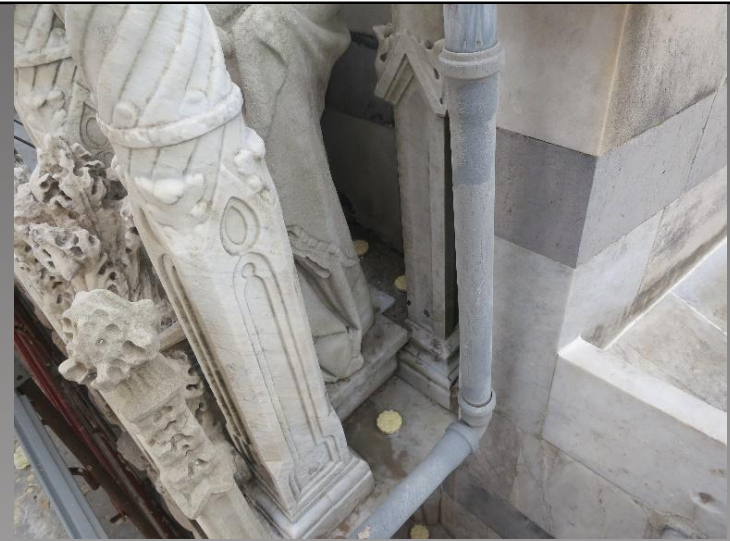
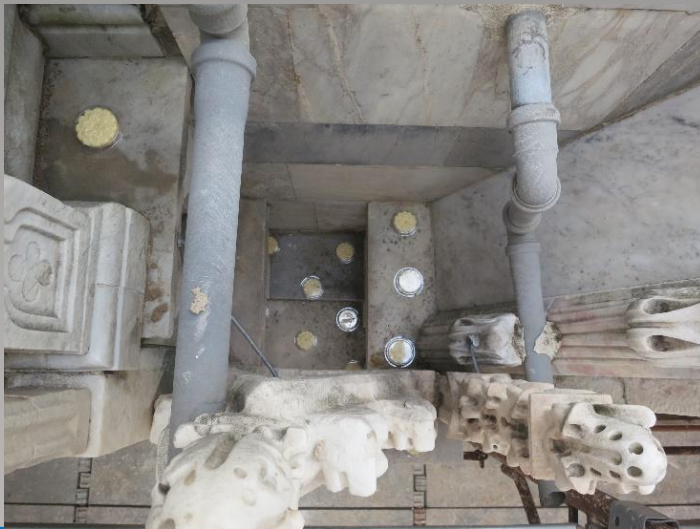
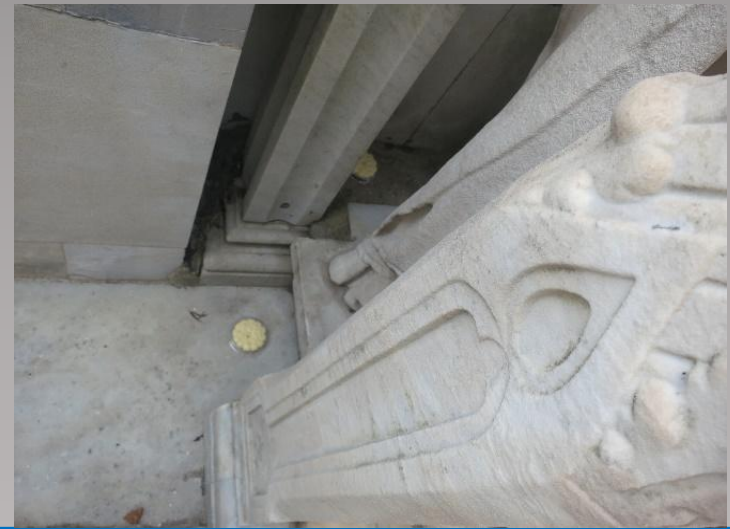
Nesting material was observed in the sheltered areas behind the statues at the third floor of the south elevation. These were treated with *Bird Free*, as shown above, to prevent nesting.

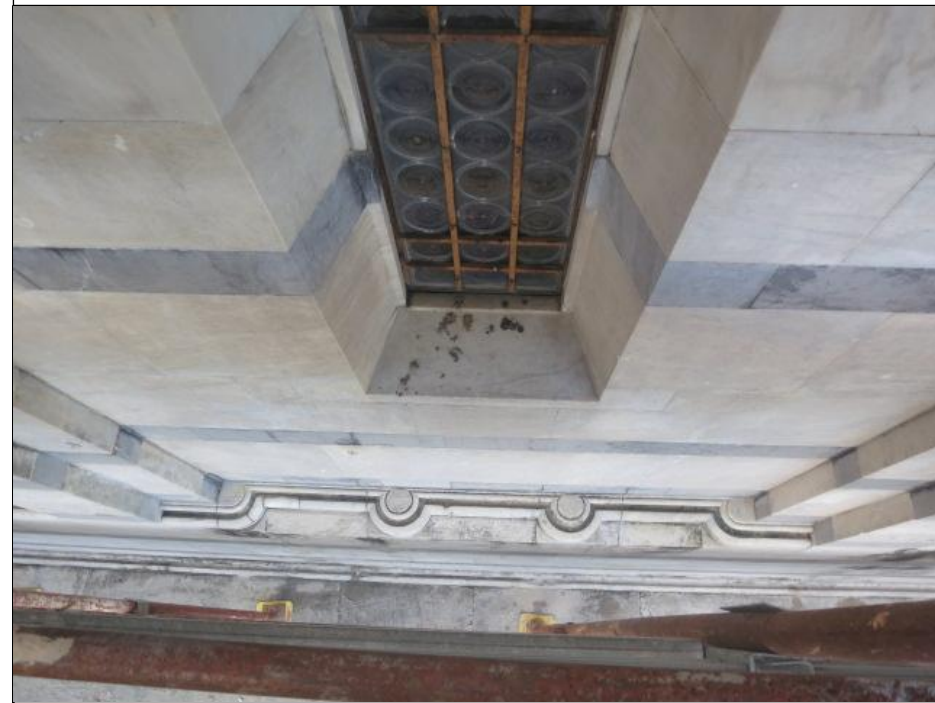
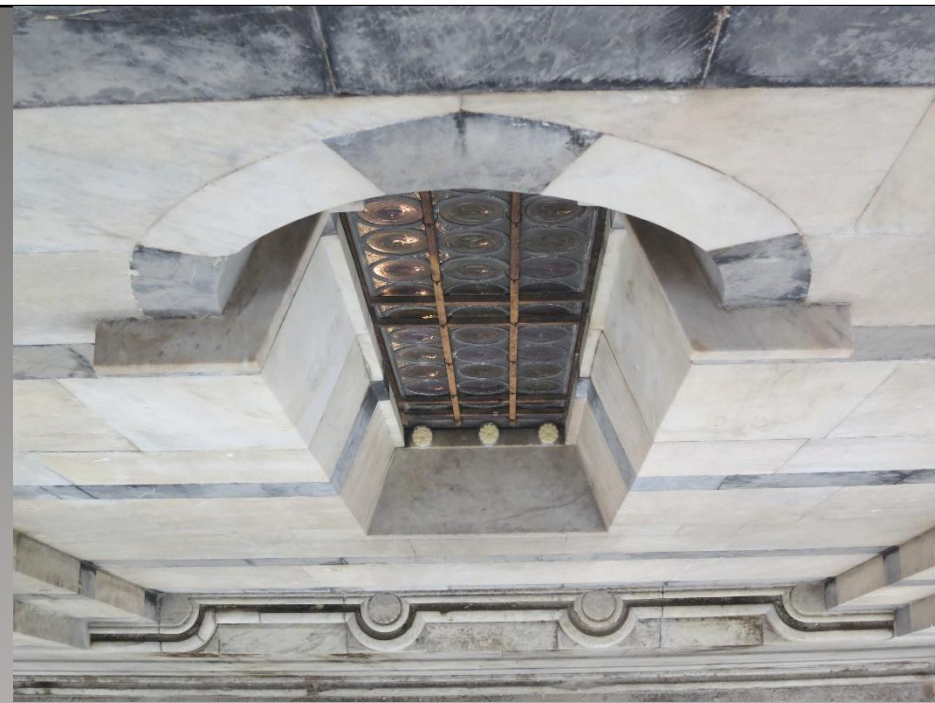
Each of the three windows at the east elevation was treated with three dishes of *Bird Free* to prevent roosting.
