# Effect of *BIRD FREE* on a night roost of feral pigeons

Anna Gagliardo

Department of Biology, University of Pisa, 56126 Pisa, Italy

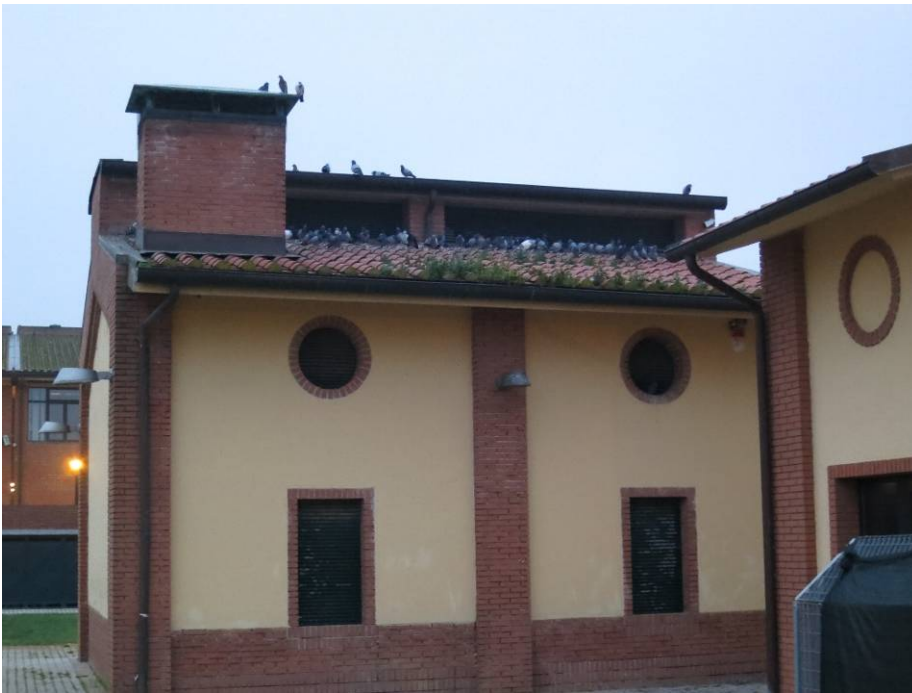
Figure 1.

In order to assess the efficacy of the product *BIRD FREE* in repelling feral pigeons we performed a test on a night roost site at the Veterinary Clinic of the University of Pisa in San Piero a Grado (Pisa). The night roost subject of the study was located on the two lower pitches of a roof of a building, which houses heating equipment (Figure 1). Hot air from the equipment is expelled through vents on either side of the building, located below the higher roof. The warm air blown out from the vents creates an ideal night roost for pigeons.

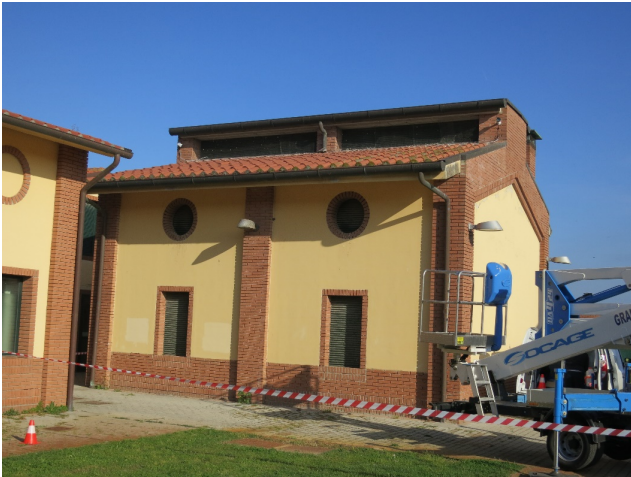
Figure 2

In order to document the presence of the birds before and after the treatment one video-camera for each pitch of the roof hosting the night roost was installed. The south roof (Figure 2) was treated with *BIRD FREE* (video-camera CAM01); the north roof (Figure 3) was treated with empty PET dishes (CAM04). Each camera recorded a picture every minute.

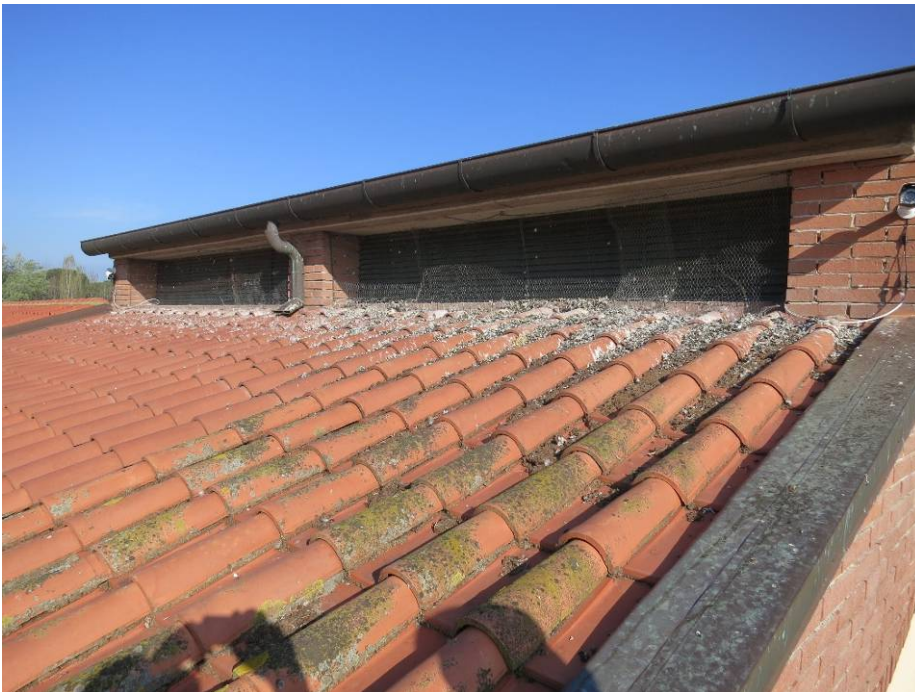
Figure 4

The dimensions of the south roof (Figure 4) are 9.09 m wide (east/west) x 4.15 m deep (north/south). The metal cladding on either side of the roof is 29.2 cm wide; the width of the tiled section of the roof, where roosting occurs is 8.51 m.

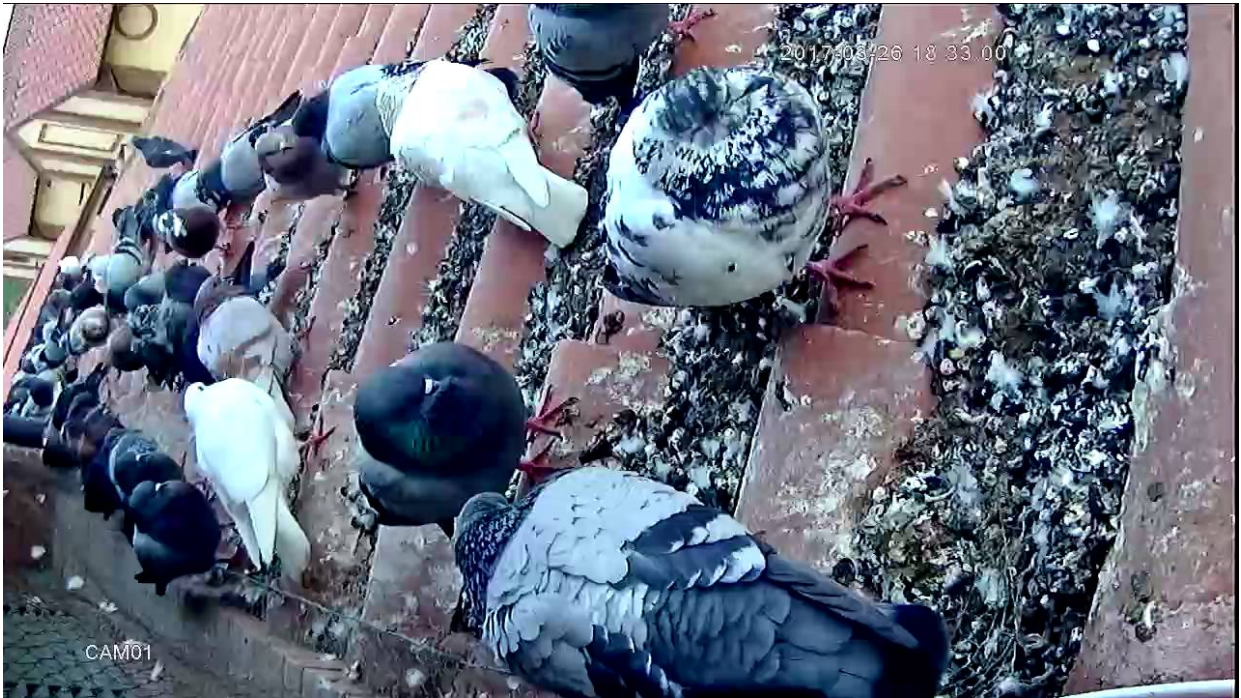
As shown by the pattern of the bird droppings the area where pigeons roosted (Figure 5) was approximately 80 cm deep towards the centre of the roof, tapering to approximately 50 cm at the sides of the tiled roof.

Figure 5. Picture of the South Roof taken on the 26<sup>th</sup> of March 2017 before the sunset (18:33), three days before the installation of *BIRD FREE*.

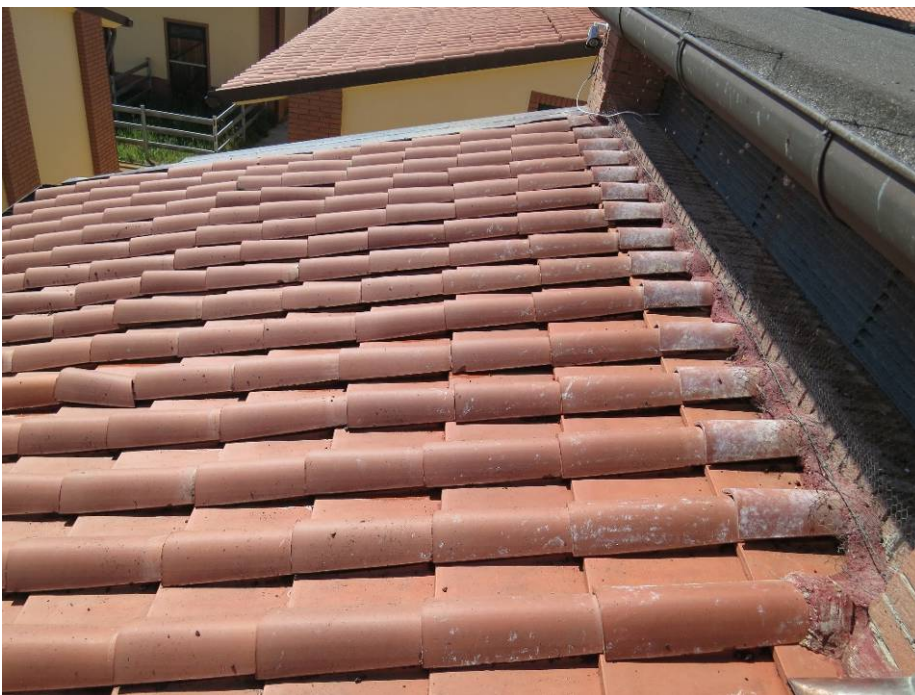
On the morning of 29<sup>th</sup> March 2017, more than 100 kg of pigeon faeces were manually removed from the south roof, which was then washed and disinfected (Figure 6).

Figure 6. South roof after bird dropping removal and cleaning.

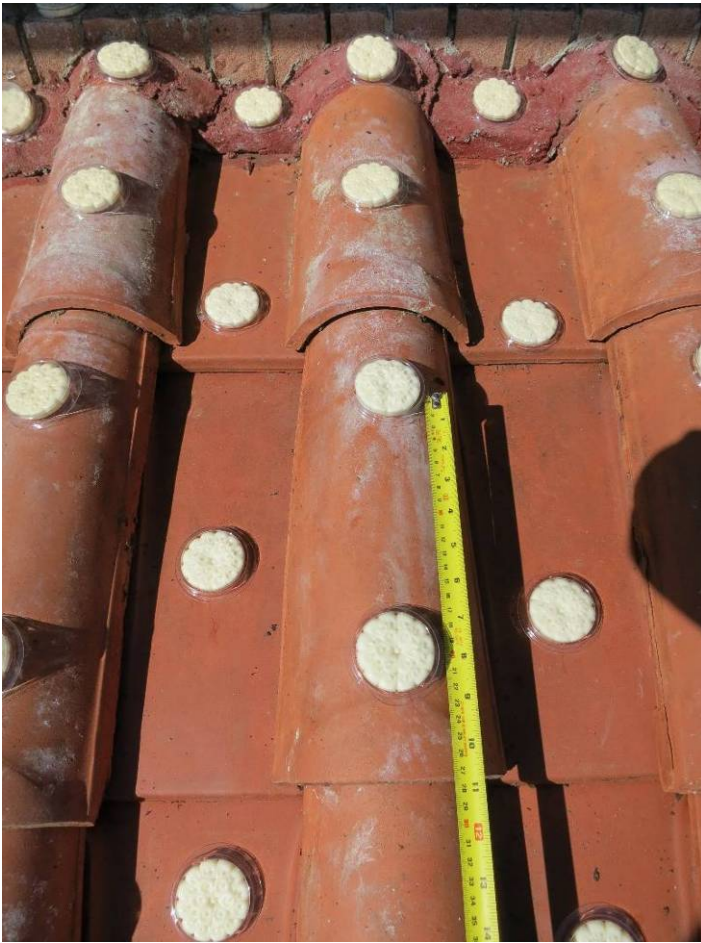
Figure 7

After the south roof dried, the dishes of *BIRD FREE* were fixed with silicone adhesive as shown in Figure 7. According to the instruction for the use of the product in pigeons' night roosts, the dishes of *BIRD FREE* must be spaced of 20cm from centre to centre. In this case, however, the distance between the apexes of the bent tiles was 28cm and therefore the dishes on the tiles were fixed at that distances from each other. In addition, dishes of *BIRD FREE* were fixed one per shingle at a

distance of 20cm from each other centre. At the top of the roof closest to the warm air ducts the dishes of *BIRD FREE* were placed at 14 cm from each other centre.

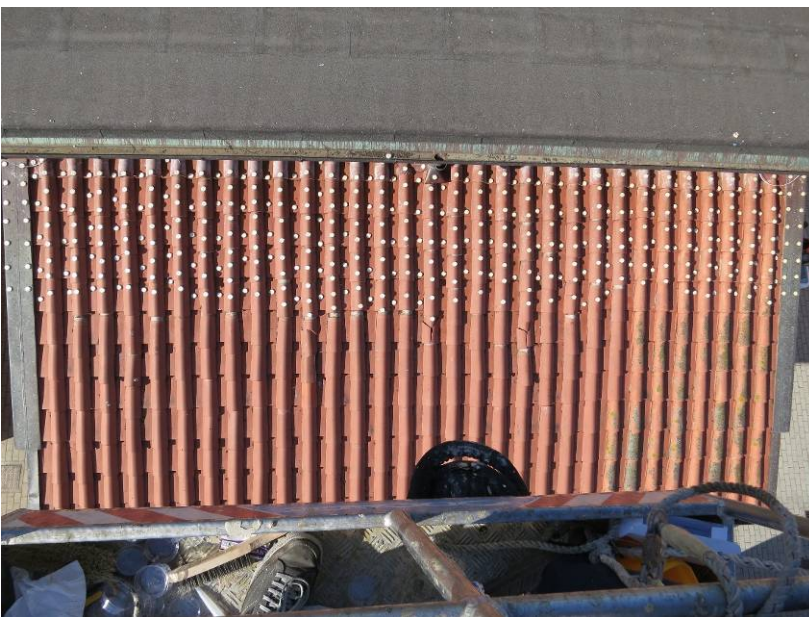
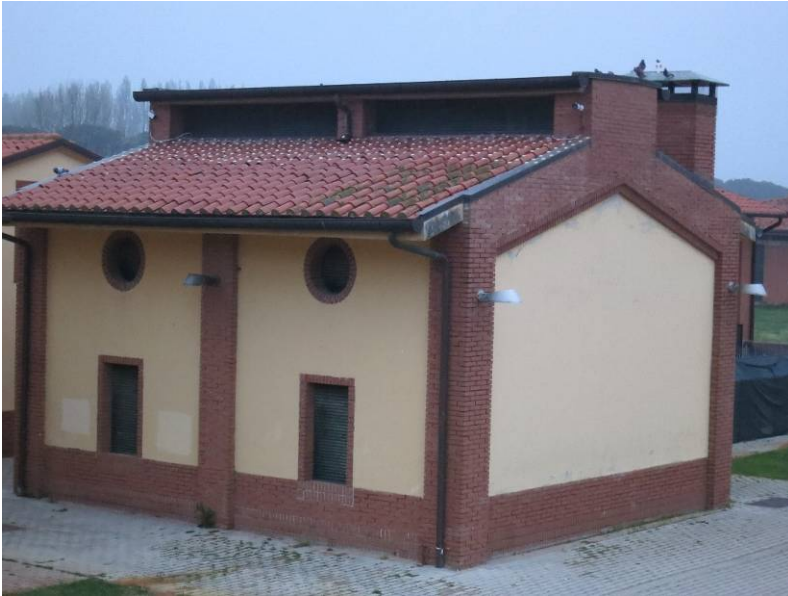
The treated area was approximately 9x1.8 m (Figure 8 and 9).

Figure 9. South roof after the installation of *BIRD FREE*

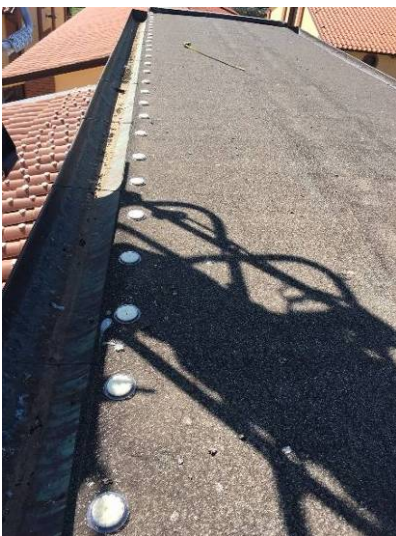
Figure 10

In order to deter pigeons from sitting on the edges of the higher roof and fouling onto the *BIRD FREE* dishes below, dishes of *BIRD FREE* were fixed to the south edge of the higher roof at 25cm centre to centre (Figure 10)

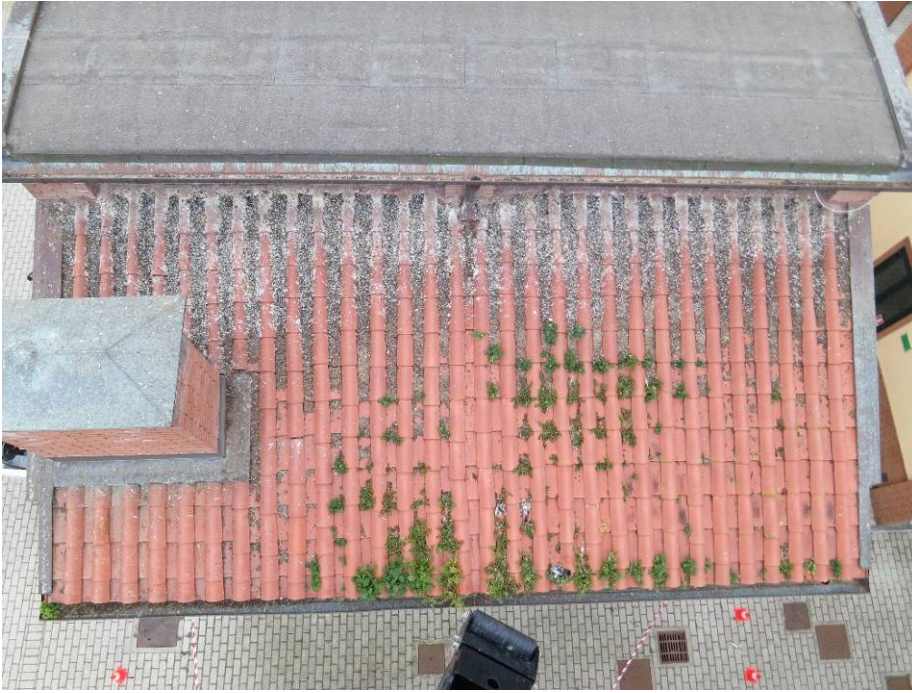
The dimensions of the north roof are the same as those of the south roof. However, there is a chimney approximately half way down the roof on the east side (Figure 11). Pigeons roost on this roof at night along the tiles close to the hot air vents, as described for the south roof (Figure 12).

Figure 11. North Roof before the treatment.

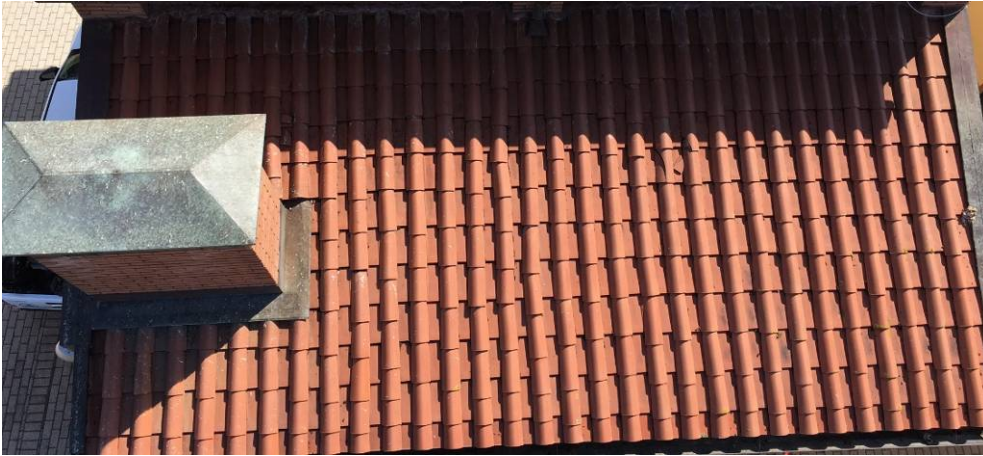
In the morning of the 30<sup>th</sup> of March 2017, more than 100kg of pigeon faeces were removed from the North roof, which was cleaned and disinfected (Figure 13).

Figure 13. North roof cleaned and disinfected.

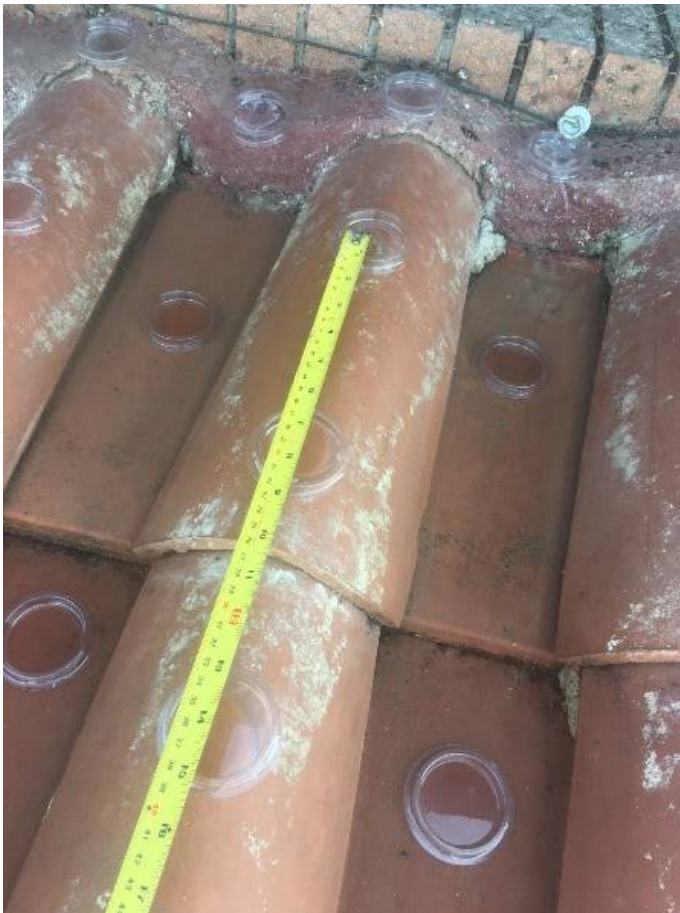
Empty PET dishes, the same as those containing the *BIRD FREE* gel, were fixed with silicone to the cleaned North roof. The empty dishes were spaced as the dishes of *BIRD FREE* fixed to the South roof. (Figure 14)

Figure 14. Empty dishes fixed on the North roof.

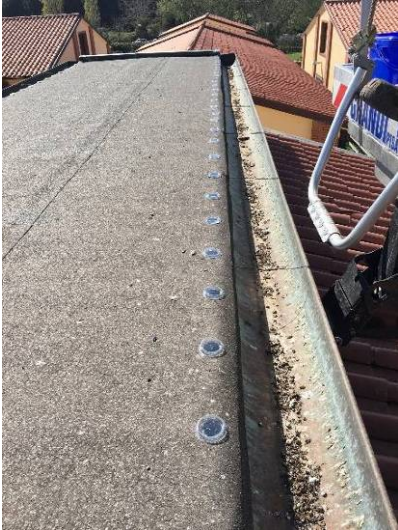
Figure 15

Empty dishes were also fitted to the north edge of the higher roof at 25cm centre to centre (Figure 15).

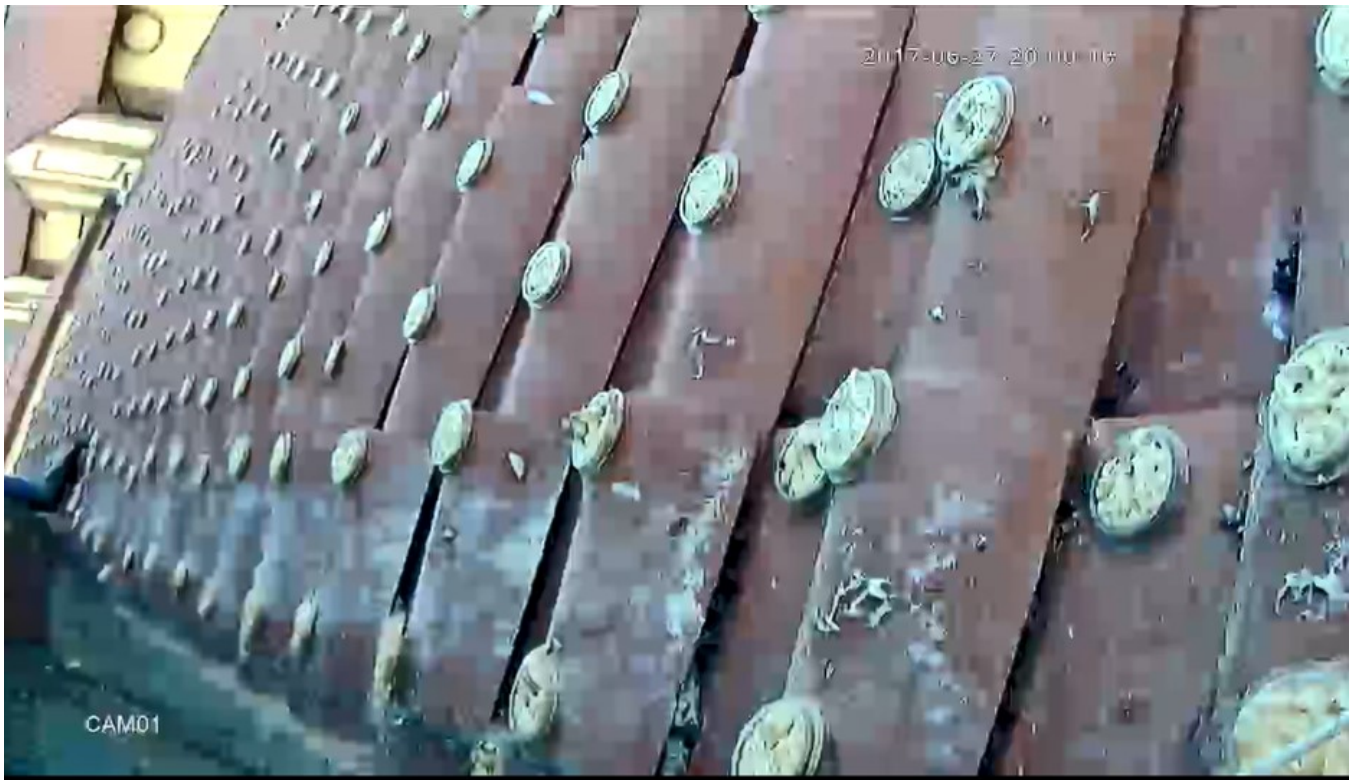
The condition of South Roof and the North Roof at the sunset of the Day 90 can be inspected in Figures 16 and 17, respectively. It is evident the accumulation of bird dropping on the tiles of the North Roof treated with Empty Dishes. By contrast, no accumulation of faeces is observed on the South roof treated with *BIRD FREE*. A year later, despite a few dishes of *BIRD FREE* had fell off from the tiles, the pigeons continued to avoid the South Roof, which was void of faeces. The condition of South Roof and the North Roof at the sunset more than 1 year after the treatment can be inspected in Figures 18 and 19, respectively. Two years after the treatment the efficacy of *BIRD FREE* was still clearly visible (see Figure 20 and 21 for the South and North roofs, respectively). Importantly, we were able to assess the efficacy of *BIRD FREE* even four years after the treatment (see Figure 22 and 23).

Figure 16. South Roof provided with *BIRD FREE*. The picture has been taken at the sunset (Day 90)

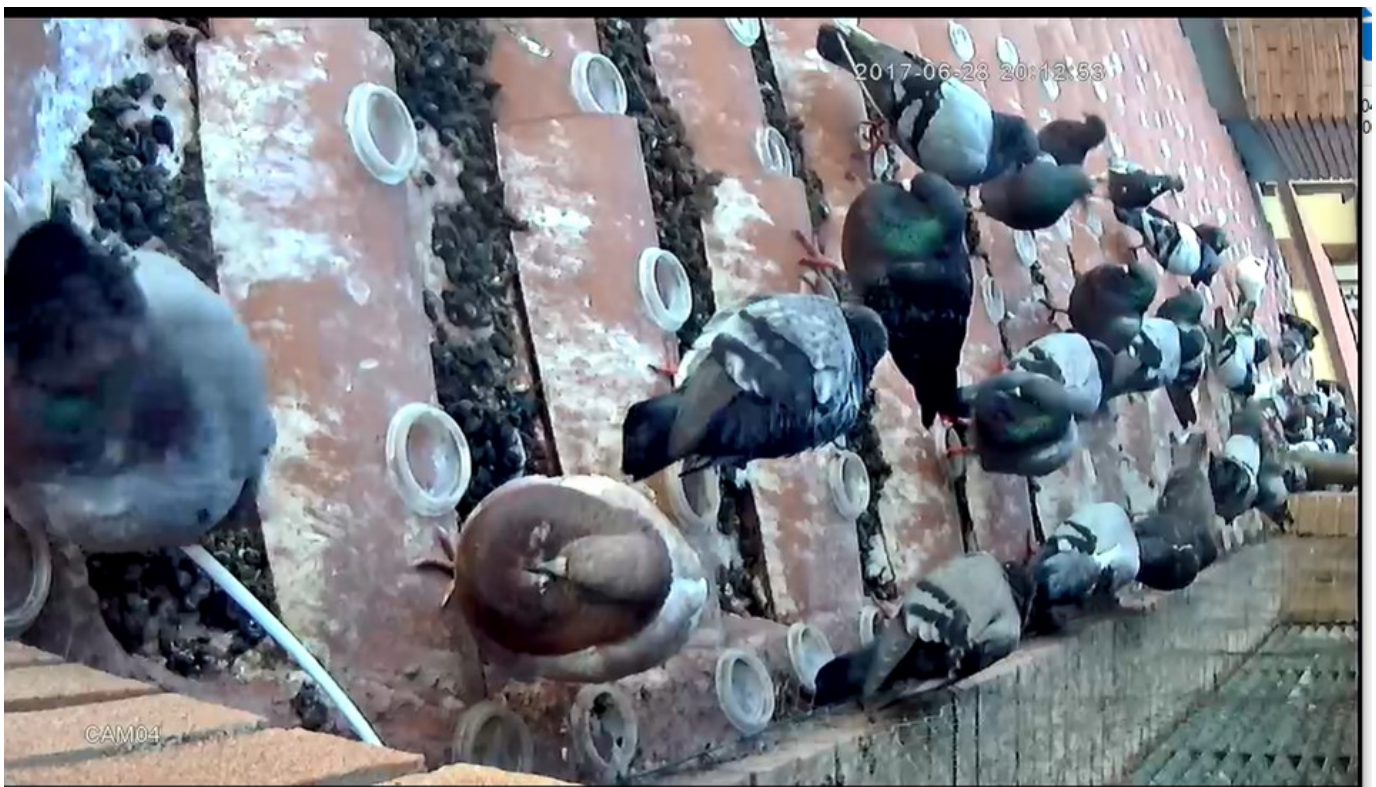
Figure 17 North Roof provided with Empty Dishes. The picture has been taken at the sunset (Day 90).

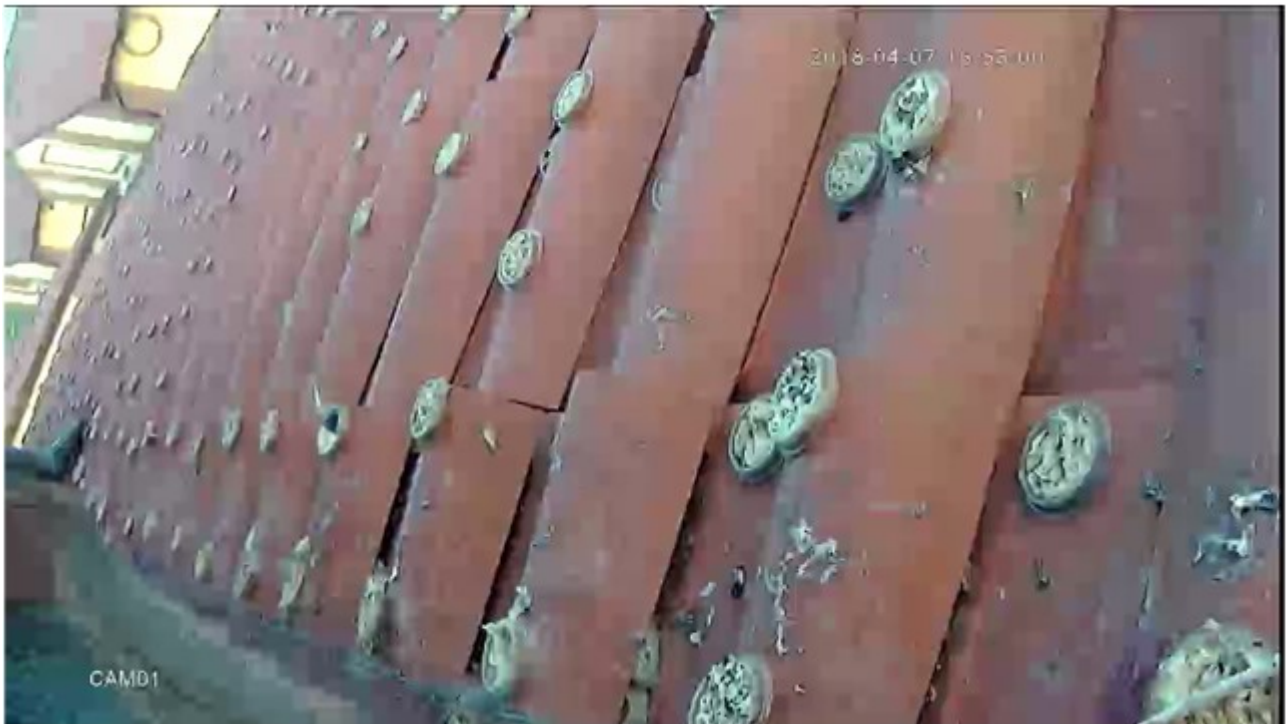
Figure 18. South Roof provided with *BIRD FREE*. The picture has been taken at the sunset after about 1 year from the installation.

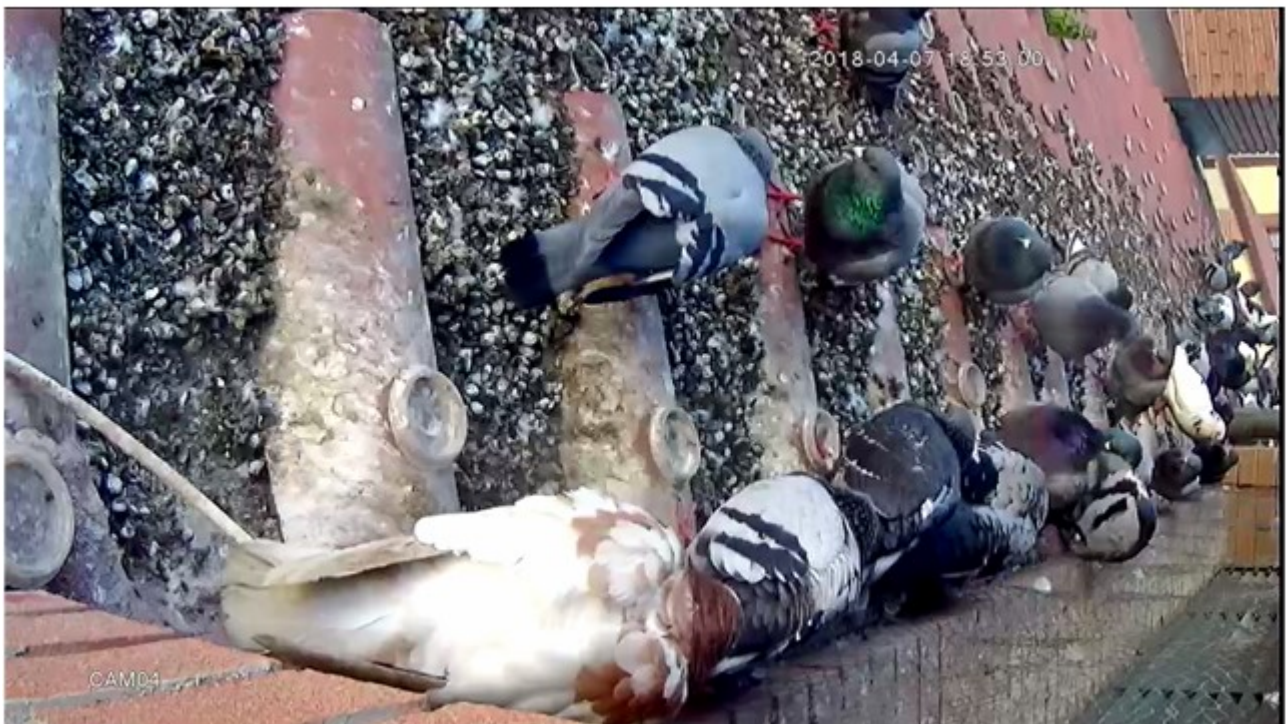
Figure 19. North Roof provided with Empty Dishes. The picture has been taken at the sunset after about 1 year from the installation.

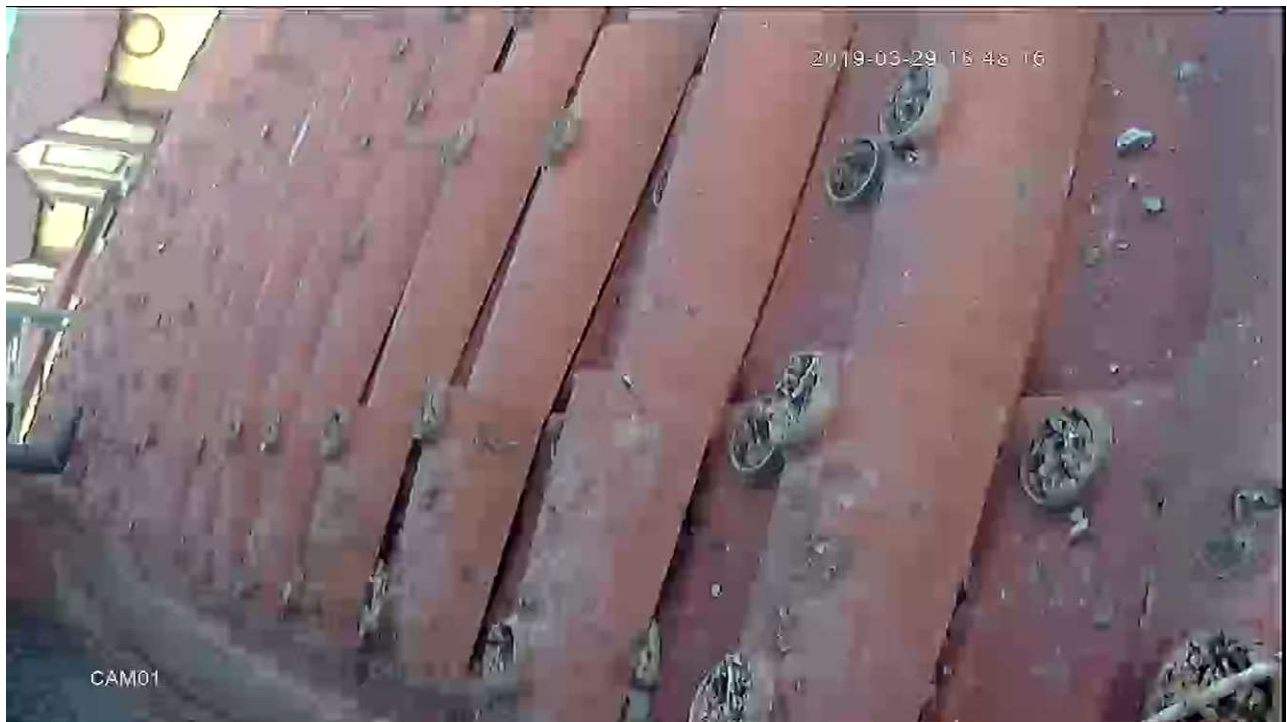
Figure 20. South roof two years after *BIRD FREE* installation

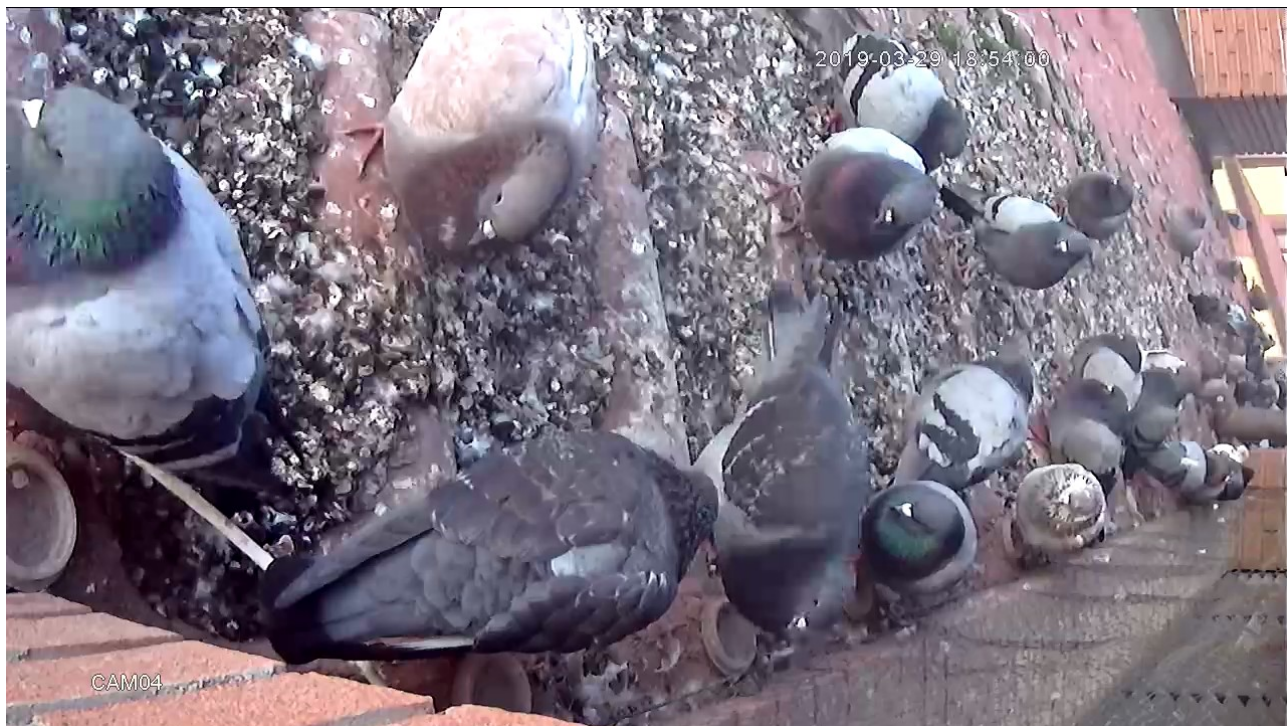
Figure 21. North roof two years after the installation with Empty Dishes

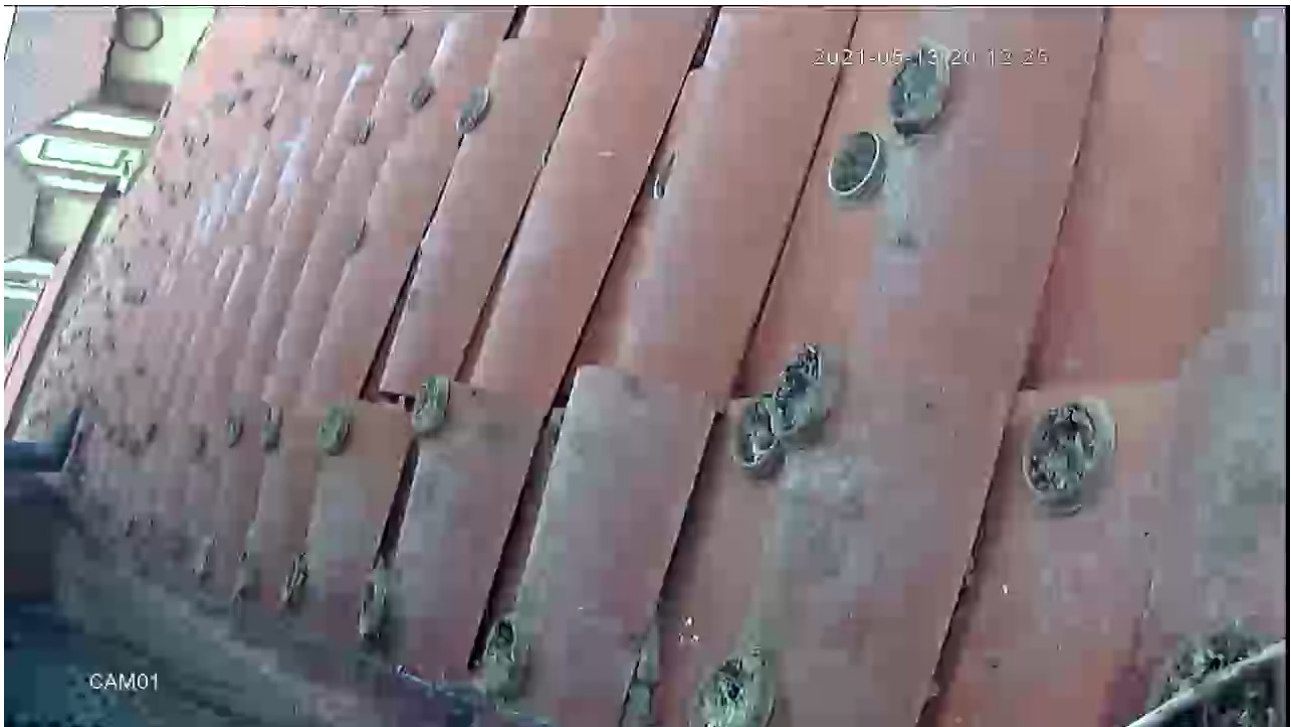
Figure 22. South roof four years after *BIRD FREE* installation

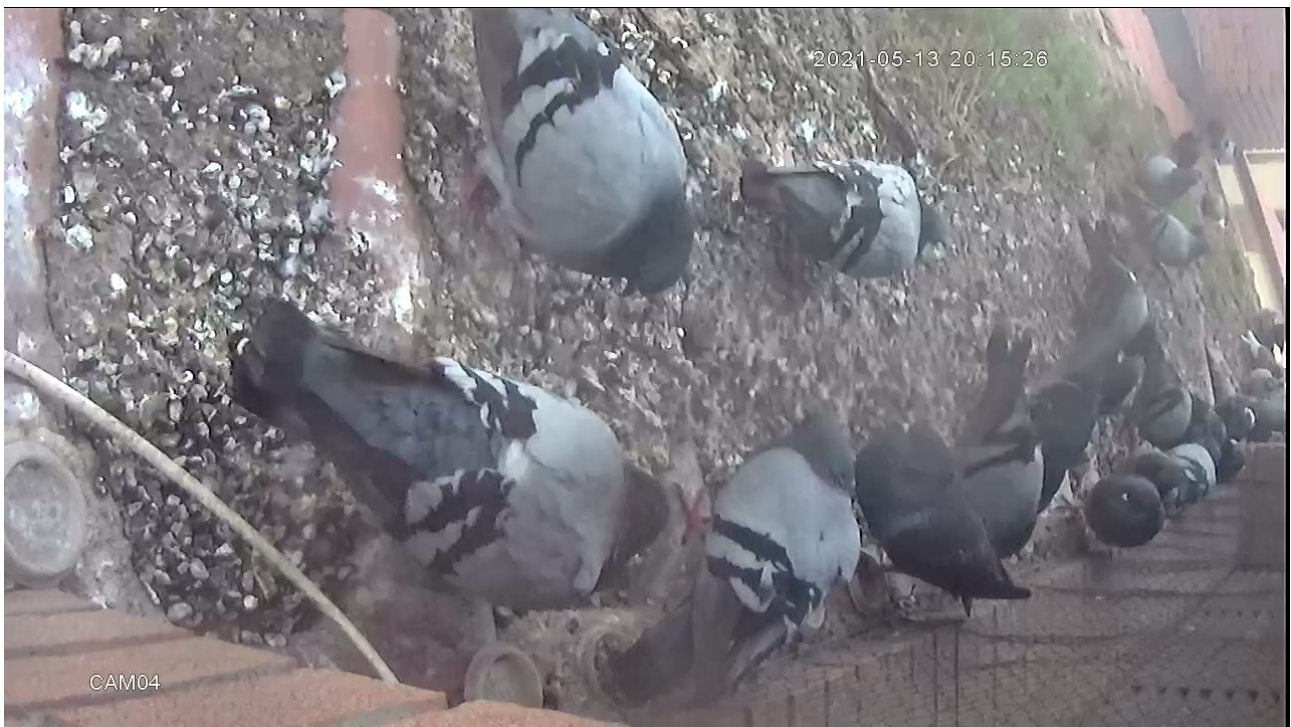
Figure 23. North roof four years after the installation with Empty Dishes
